# Guide to Corrosion Management of REINFORCED CONCRETE STRUCTURES

Sohanghpurwala, Ali Akbar.

This guide was developed by Task Group (TG) 400, "Reinforced Concrete: Corrosion Management," which is administered by Specific Technology Group (STG) 01, "Reinforced Concrete." It is also sponsored by STG 46, "Building Management." This guide is published by NACE under the auspices of STG 01.

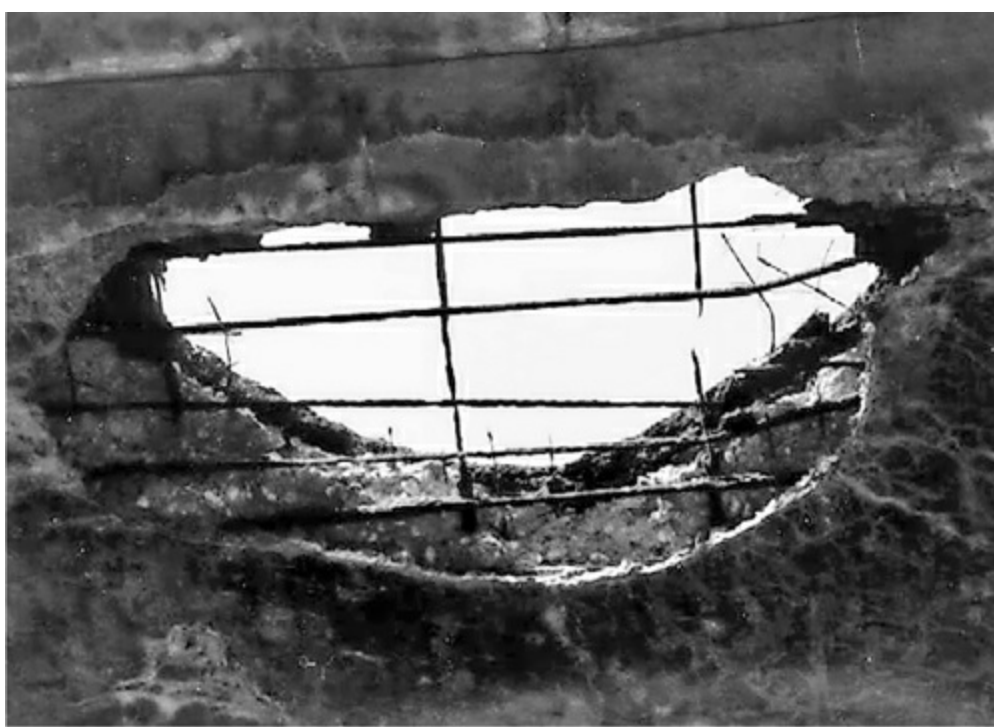
**FIGURE 1** Loss of Cross-Section of Reinforcement as a Result of Corrosion

Concrete is a very durable material; however, its durability is compromised by corrosion of reinforcement in certain environments or exposure conditions. Corrosion of conventional reinforcement results in cracking, delamination, and spalling of the cover concrete, and in extreme cases can result in significant loss of reinforcement cross-section, as is apparent in Figure 1. This degradation has an impact on the operation of the structure and/or results in the reduction of overall structural integrity. Consequences of corrosion on a stressed (both pre- and post-tensioned) reinforcement are far more severe and can result in the failure of the stressed high-strength steel element. Failure of a critical number of stressed elements can result in failure of that bridge element.

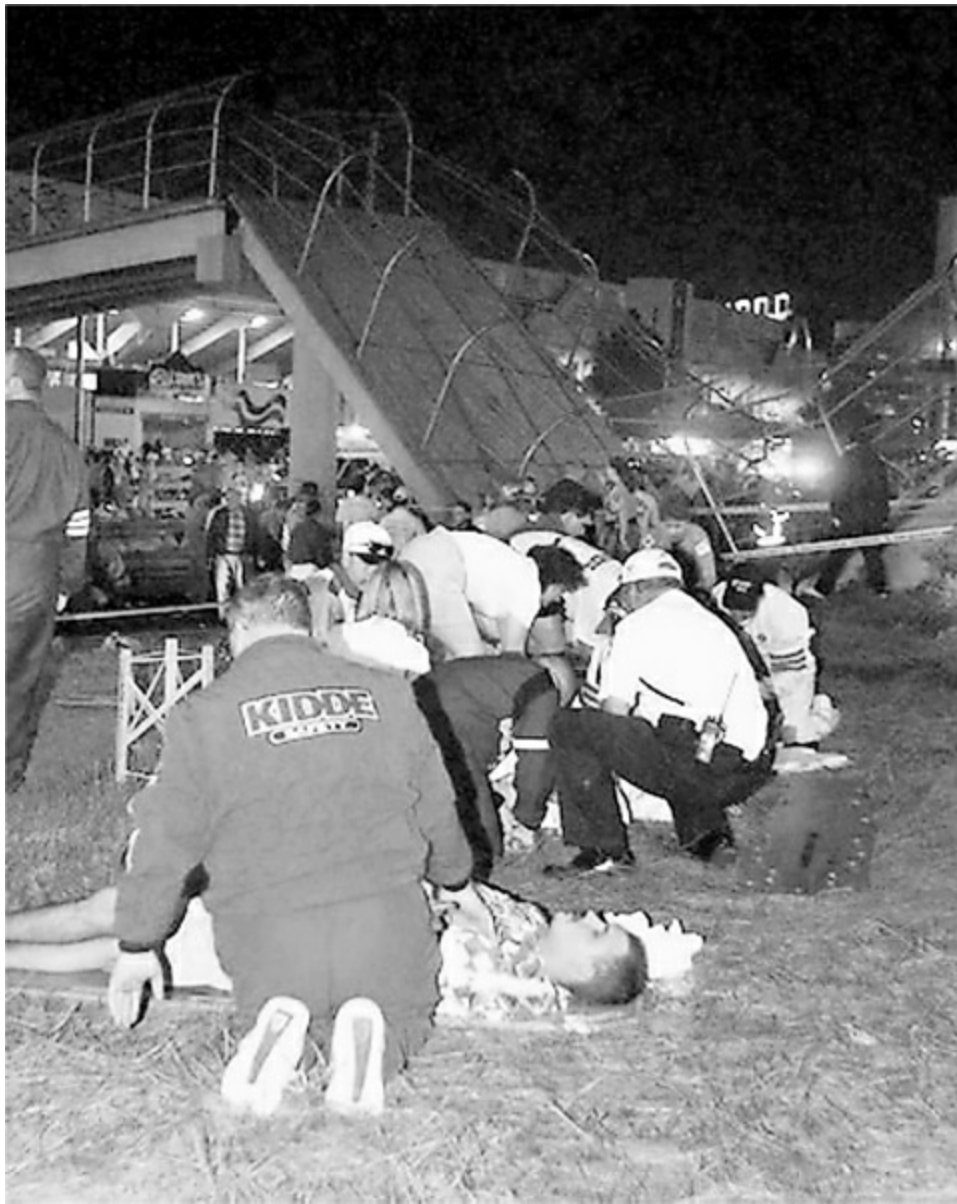
**FIGURE 2** Lowe's Motor Speedway Collapse

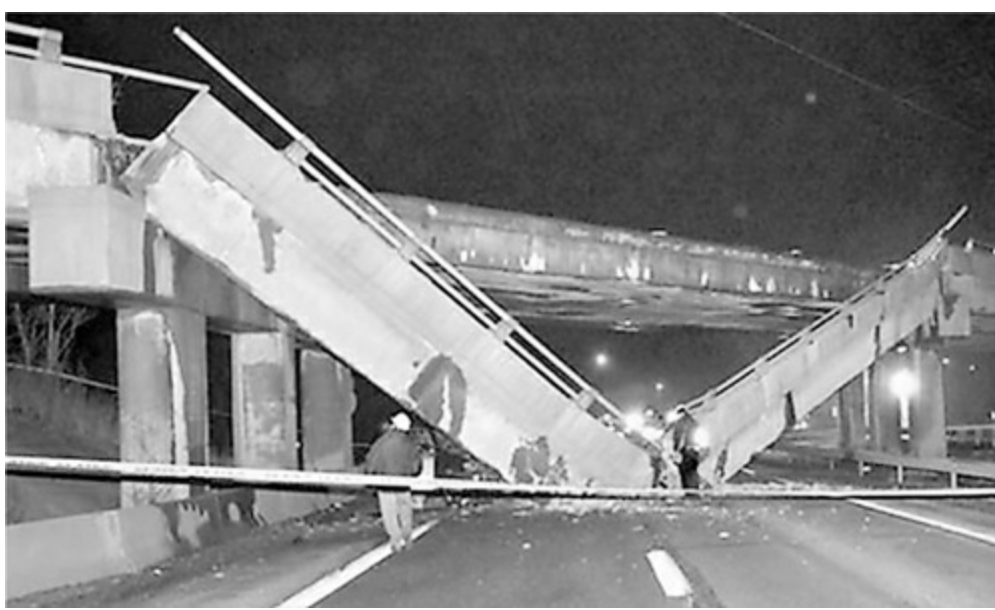
**FIGURE 3** Collapse of I-70 Overpass as a Result of Prestressing Cable Corrosion

There are several cases of catastrophic failures of bridge structures in other parts of the world from corrosion of stressed reinforcement, both pre-stressed and post-tensioned. The first known failure occurred in 1967; the Brickton Meadows Foot Bridge collapsed in Hampshire, U.K., because of corrosion of post-tensioned tendons. Corrosion of post-tensioning also resulted in the failures of the Ynys-y-Gwas Bridge located in Wales in 1985 and the Malle Bridge in Belgium in 1992. Similarly, corrosion of prestressing strands resulted in the collapse of a five-year-old Lowe's Motor Speedway Bridge in Charlotte, North Carolina, in 2000. Figure 2 displays a photograph of the failed bridge. A 45-year-old overpass on Interstate 70 (I-70) located in Washington County, Pennsylvania, failed in 2005, as shown in Figure 3.

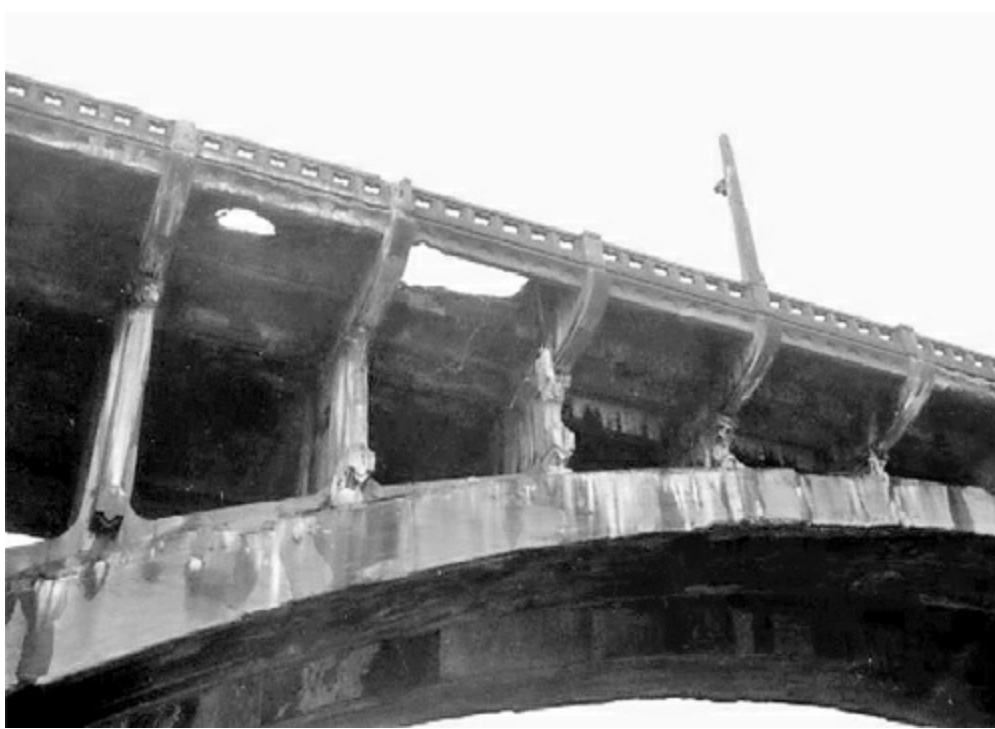
**FIGURE 4** Corrosion-Induced Damage on Bridge Deck

Generally, corrosion of conventional reinforcement provides sufficient early warning to allow remediation measures to be implemented. For example, the superstructure of the historic Jefferson Street Bridge in Fairmont, West Virginia, shown in Figure 4, had developed significant corrosion-induced damage. Although the reduction in operating capacity and the resulting danger posed to the driving public is clearly observable, it was not expected to catastrophically fail. However, rehabilitation cost approximately \$25 million.
