CORRCOMPILATIONS: CONCRETE

Long-Term Performance of Concrete Repairs in Complex Conditions

Dr. Marita L. Berndt
Aurecon Australia
850 Collins St
Docklands, Vic 3005
Australia

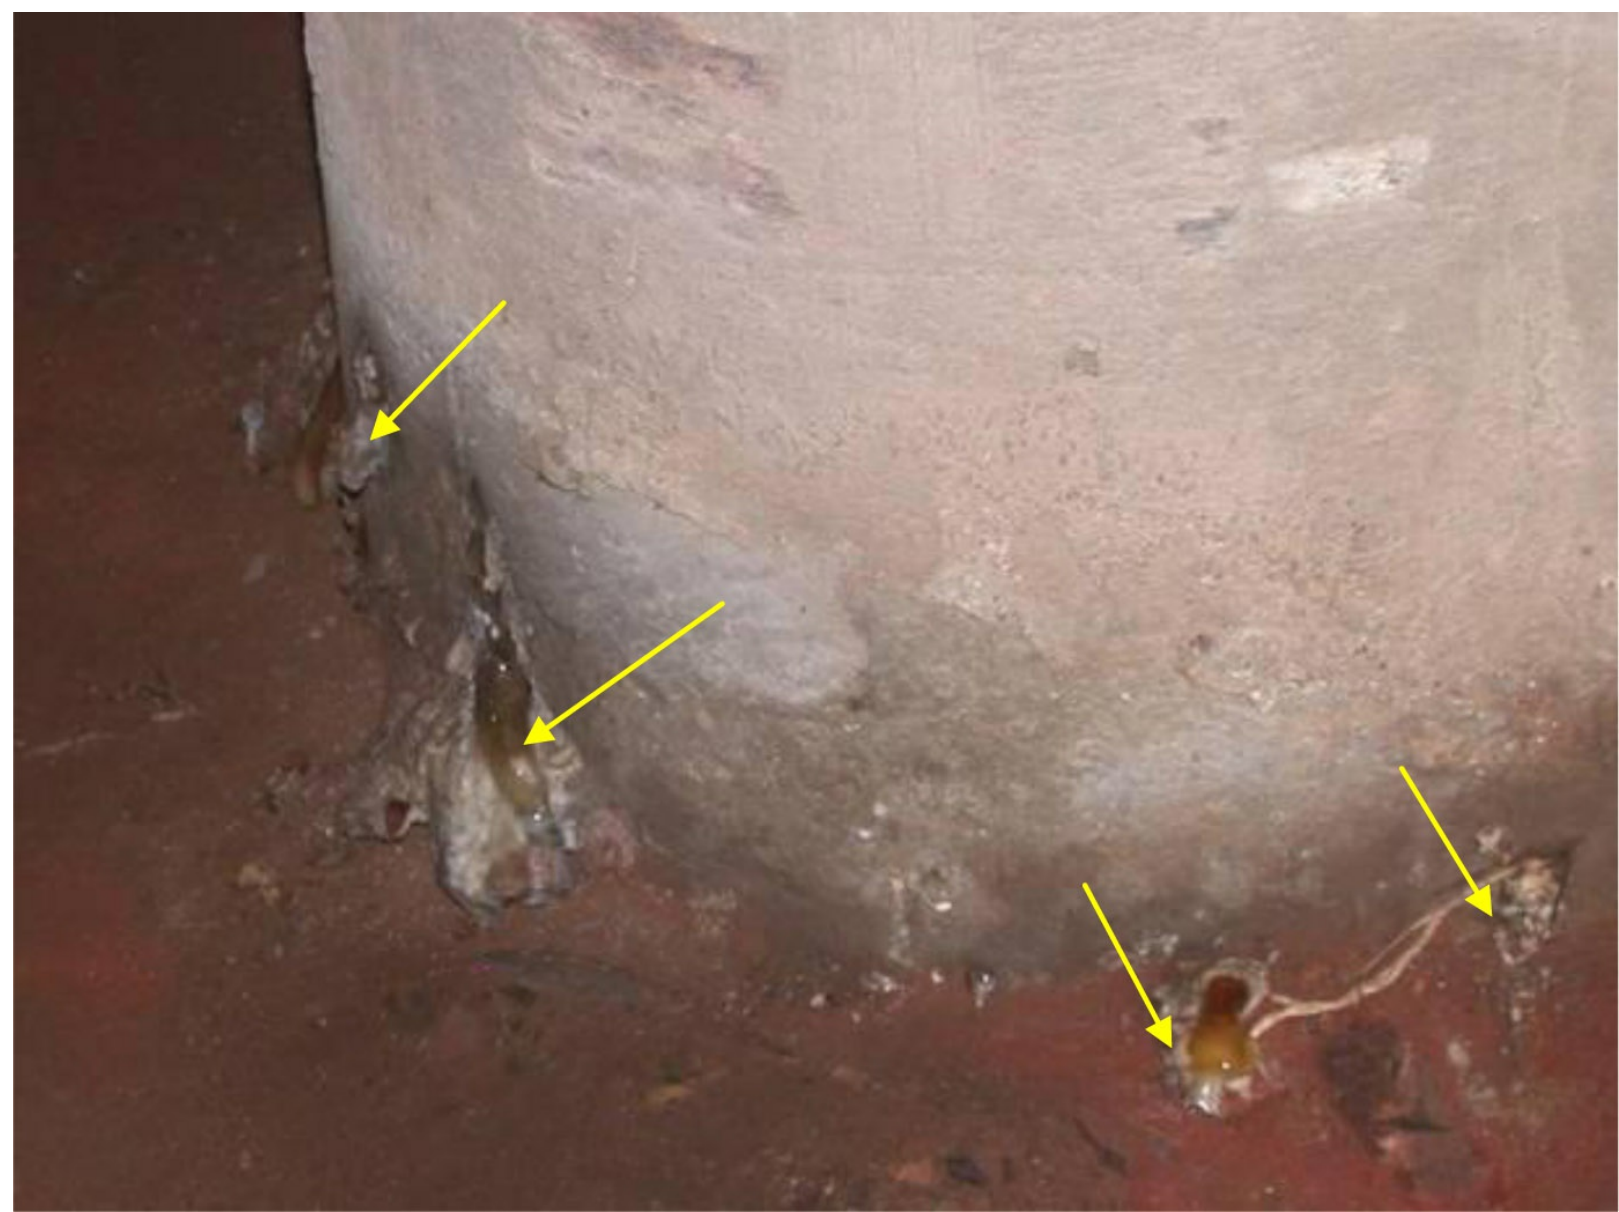
The recent condition assessment found that all of the Shed 1 piles exhibited gel exudations due to ASR and exposed aggregate at the base. Examples of these features are depicted in [Figures 1 and 2](#). The exudations were a white-brown color and typically located in the lower 150 mm of the piles, although up to 300-400 mm from the soil level in the worst affected piles. The tendency for ASR to be more prevalent at the base of the piles corresponds with higher moisture conditions close to the soil level.

Figure 1: ASR Gel Exudations at Base of a Shed 1 Pile (arrowed)
